# Access Compliance Report Public Rights-of-Way (Curb Ramps)

| Main Street: SIENNA_PKWY | | Cross Street: WINDMILL_AVE | | Location: | N |
| ADA ID: RPRK211109115242 | Ramp Type: Type 1 - Perpendicular | Initial Pass/Fail: Fail | Overall Compliance: No | Severity Score: | 30 |

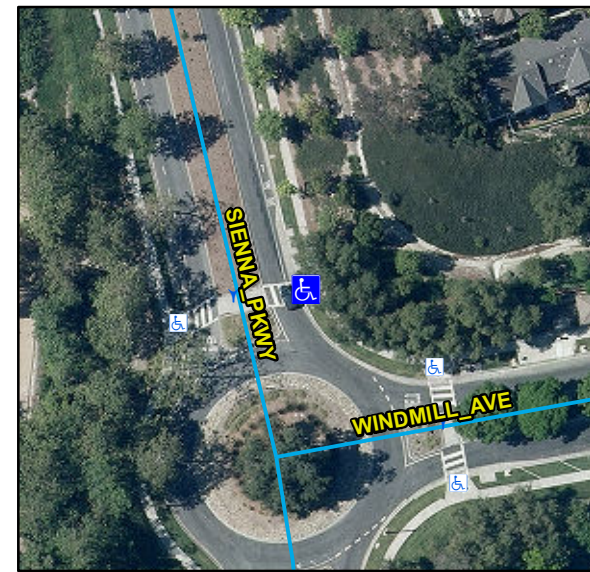
R304.2.2, R204.3, R304.5.3, STD 1115

| Compliance | Description | Data | Compliance | Description | Data |
|---|---|---|---|---|---|
| No | Ramp Run Slope (%) | 9.1 | N/A | Flare Slope LT (%) | N/A |
| No | Ramp Cross Slope (%) | 6.3 | N/A | Flare Traversable LT | N/A |

Remove & Replace Entire Ramp.
