# Access Compliance Report Public Rights-of-Way (Curb Ramps)

| Main Street: SIENNA_PKWY | | Cross Street: WINDMILL_AVE | | Location: | N |
| ADA ID: RPRK211109115544 | Ramp Type: Type 1 - Perpendicular | Initial Pass/Fail: Fail | Overall Compliance: No | Severity Score: | 45 |

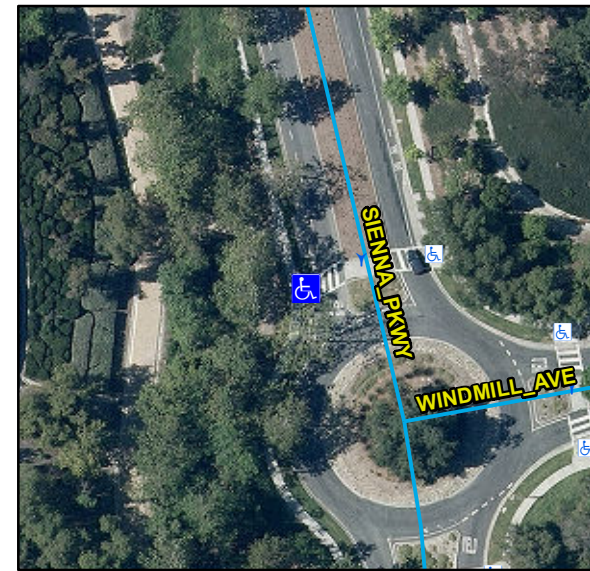
| Compliance | Description | Data | Compliance | Description | Data |
|---|---|---|---|---|---|
| No | Ramp Run Slope (%) | 8.8 | N/A | Flare Slope LT (%) | N/A |
| No | Ramp Cross Slope (%) | 7.1 | N/A | Flare Traversable LT | N/A |

**Remove & Replace Entire Ramp.**

**R304.2.2, R204.3, R304.5.3, STD 1115**

Total Cost: \$ 3080
