# Access Compliance Report Public Rights-of-Way (Curb Ramps)

| Main Street: SIENNA_PKWY | | Cross Street: WINDMILL_AVE | | Location: | S |
| ADA ID: RPRK211109115657 | Ramp Type: Type 1 - Perpendicular | Initial Pass/Fail: Fail | Overall Compliance: No | Severity Score: | 32 |

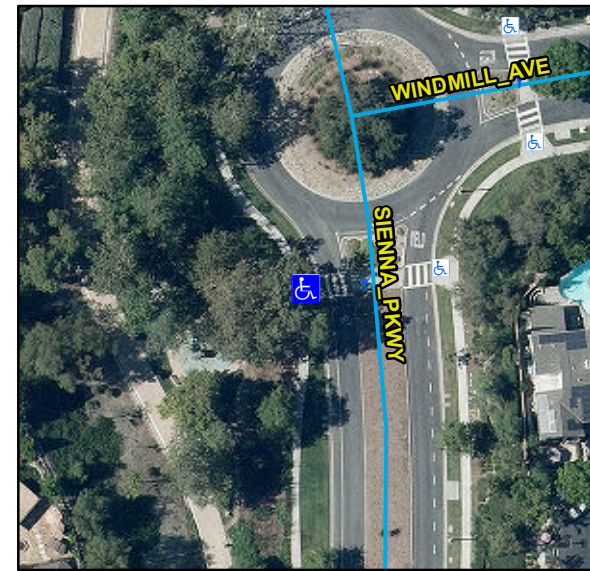
| Compliance | Description | Data | Compliance | Description | Data |
|---|---|---|---|---|---|
| No | Ramp Run Slope (%) | 13.3 | N/A | Flare Slope LT (%) | N/A |
| N/A | Gutter Ponding | N/A | No | Curb Slope | 5.6 |

Remove & Replace Entire Ramp.

R304.2.2, R204.3, STD 1115

Total Cost: \$ 3080
