# Access Compliance Report Public Rights-of-Way (Curb Ramps)

| Main Street: SIENNA_PKWY | | Cross Street: WINDMILL_AVE | | Location: | S |
| ADA ID: RPRK211109120000 | Ramp Type:Type 1 - Perpendicular | Initial Pass/Fail: Fail | Overall Compliance: No | Severity Score: | 32 |

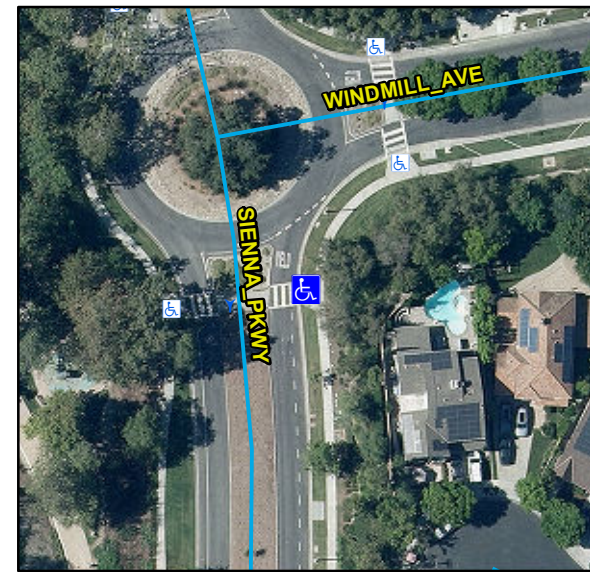
| Compliance | Description | Data | Compliance | Description | Data |
|---|---|---|---|---|---|
| No | Ramp Run Slope (%) | 12.8 | N/A | Flare Slope LT (%) | N/A |
| No | Ramp Cross Slope (%) | 4 | N/A | Flare Traversable LT | N/A |
| N/A | Gutter Ponding | N/A | No | Curb Slope | 16.9 |

Possible Solutions:

Remove & Replace Entire Ramp.

R304.2.2, R204.3, R304.5.3, STD 1115
