# Access Compliance Report Public Rights-of-Way (Curb Ramps)

| Main Street: WINDMILL_AVE | | Cross Street: SIENNA_PKWY | | Location: | E |
| ADA ID: RPRK211109120102 | Ramp Type: Type 1 - Perpendicular | Initial Pass/Fail: Fail | Overall Compliance: No | Severity Score: | 15 |

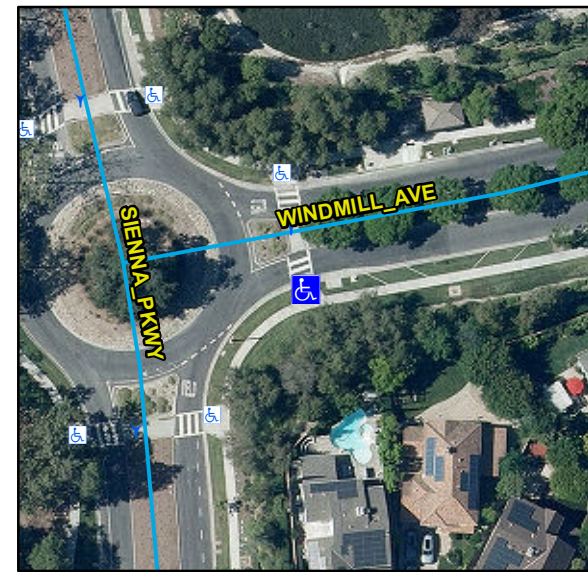
R304.2.2, R204.3, STD 1115

| Compliance | Description | Data | Compliance | Description | Data |
|---|---|---|---|---|---|
| No | Ramp Run Slope (%) | 9.7 | N/A | Flare Slope LT (%) | N/A |

Remove & Replace Entire Ramp.

Total Cost: \$ 3080
