# Access Compliance Report Public Rights-of-Way (Curb Ramps)

Main Street: SUTHERLAND\_DR Cross Street: STERLING\_GLEN Location: SW

ADA ID: RPRK211109120845 Ramp Type: Type 4 - Parallel Initial Pass/Fail: Fail Overall Compliance: No Severity Score: 30

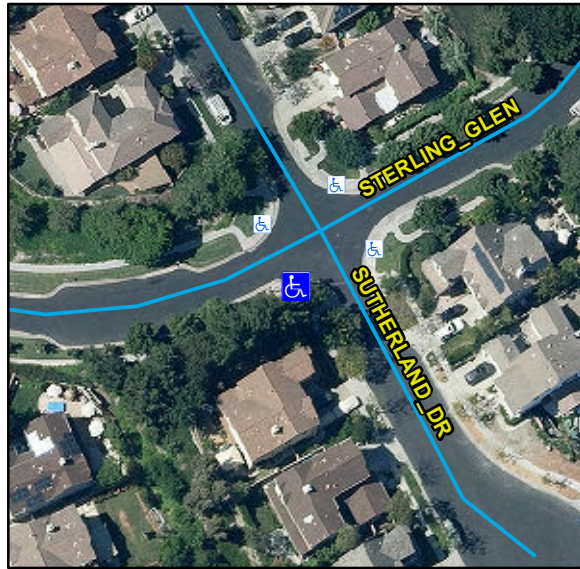
| Compliance | Description | Data | Compliance | Description | Data |
|---|---|---|---|---|---|
| No | Ramp Run Slope LT (%) | 16.4 | Yes | Ramp Run Slope RT (%) | 5.5 |

Remove & Replace Curb Ramp With Two New Directional Ramps or Equivalent.

R204.3, R304.3.2, STD 1115
