# Access Compliance Report Public Rights-of-Way (Curb Ramps)

Main Street: STERLING\_GLEN Cross Street: SUTHERLAND\_DR Location: SE

ADA ID: RPRK211109121102 Ramp Type: Type 4 - Parallel Initial Pass/Fail: Fail Overall Compliance: No Severity Score: 16

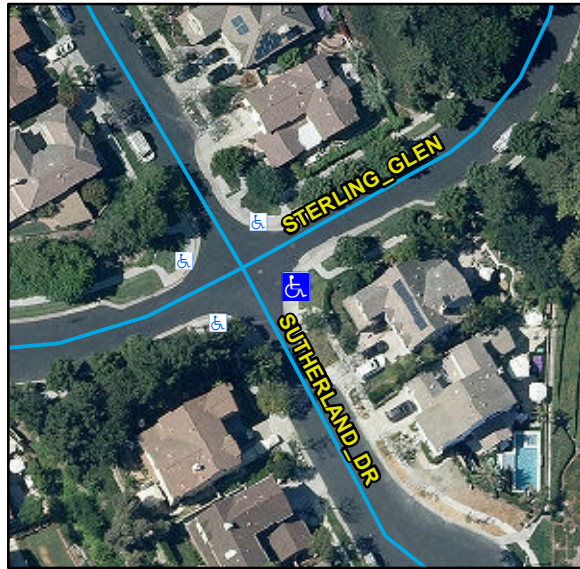
| Compliance | Description | Data | Compliance | Description | Data |
|---|---|---|---|---|---|
| No | Ramp Run Slope LT (%) | 9.1 | Yes | Ramp Run Slope RT (%) | 1.9 |
| Yes | Ramp Cross Slope LT (%) | 0.5 | No | Ramp Cross Slope RT (%) | 3.2 |

**Remove & Replace Curb Ramp With Two New Directional Ramps or Equivalent.**

**R204.3, R304.3.2, R304.5.3, STD 1115**
