# Access Compliance Report Public Rights-of-Way (Curb Ramps)

Main Street: SUTHERLAND\_DR Cross Street: STERLING\_GLEN Location: NE

ADA ID: RPRK211109121257 Ramp Type: Type 4 - Parallel Initial Pass/Fail: Fail Overall Compliance: No Severity Score: 16

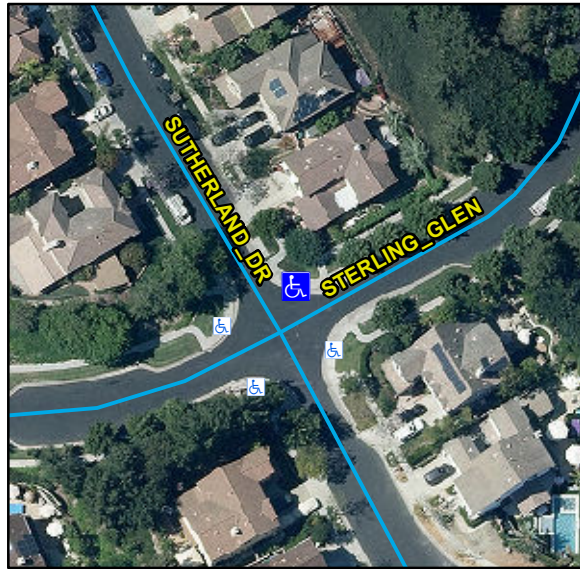
| Compliance | Description | Data | Compliance | Description | Data |
|---|---|---|---|---|---|
| Yes | Ramp Run Slope LT (%) | 1.1 | No | Ramp Run Slope RT (%) | 10.5 |

**Remove & Replace Curb Ramp With Two New Directional Ramps or Equivalent.**

**R204.3, R304.3.2, STD 1115**
