# Access Compliance Report Public Rights-of-Way (Curb Ramps)

Main Street: STERLING\_GLEN Cross Street: SUTHERLAND\_DR Location: NW

ADA ID: RPRK211109121456 Ramp Type: Type 4 - Parallel Initial Pass/Fail: Fail Overall Compliance: No Severity Score: 32

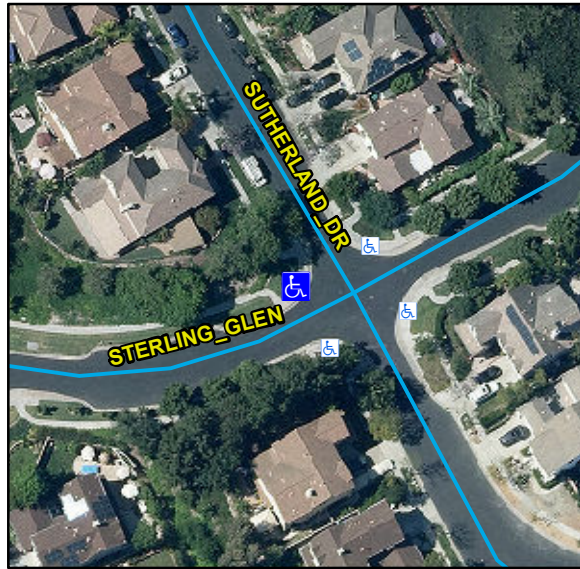
| Compliance | Description | Data | Compliance | Description | Data |
|---|---|---|---|---|---|
| Yes | Ramp Run Slope LT (%) | 6.9 | No | Ramp Run Slope RT (%) | 13.4 |
| No | Ramp Cross Slope LT (%) | 2.4 | Yes | Ramp Cross Slope RT (%) | 1.5 |

Remove & Replace Curb Ramp With Two New Directional Ramps or Equivalent.
