# Access Compliance Report Public Rights-of-Way (Curb Ramps)

| Main Street: SNAPDRAGON_ST | | Cross Street: BLUE_SPRUCE_DR | | Location: | W |
| ADA ID: RPRK211109123648 | Ramp Type: Type 1 - Perpendicular | Initial Pass/Fail: Fail | Overall Compliance: No | Severity Score: | 15 |

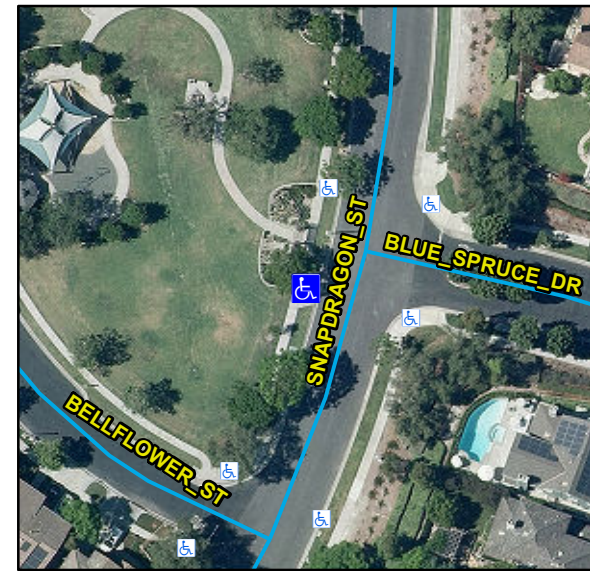
R304.2.2, R204.3, STD 1115

| Compliance | Description | Data | Compliance | Description | Data |
|---|---|---|---|---|---|
| No | Ramp Run Slope (%) | 10.8 | N/A | Flare Slope LT (%) | N/A |
| N/A | Gutter Ponding | N/A | No | Curb Slope | 12.3 |

Remove & Replace Entire Ramp.

Total Cost: \$ 3080
