# Access Compliance Report Public Rights-of-Way (Curb Ramps)

Main Street: BLUE\_SPRUCE\_DR Cross Street: SNAPDRAGON\_ST Location: S

ADA ID: RPRK211109123804 Ramp Type: Type 4 - Parallel Initial Pass/Fail: Fail Overall Compliance: No Severity Score: 2

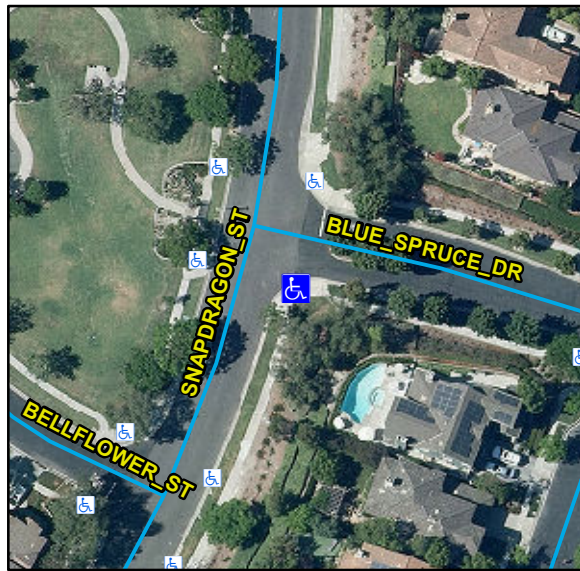
| Compliance | Description | Data | Compliance | Description | Data |
|---|---|---|---|---|---|
| Yes | Ramp Cross Slope LT (%) | 2 | No | Ramp Cross Slope RT (%) | 2.3 |

**Remove & Replace Curb Ramp With Two New Directional Ramps or Equivalent.**

R204.3, R304.5.3, STD 1115
