# Access Compliance Report Public Rights-of-Way (Curb Ramps)

Main Street: SNAPDRAGON\_ST Cross Street: BLUE\_SPRUCE\_DR Location: E

ADA ID: RPRK211109124013 Ramp Type: Type 4 - Parallel Initial Pass/Fail: Pass Overall Compliance: No Severity Score: 25

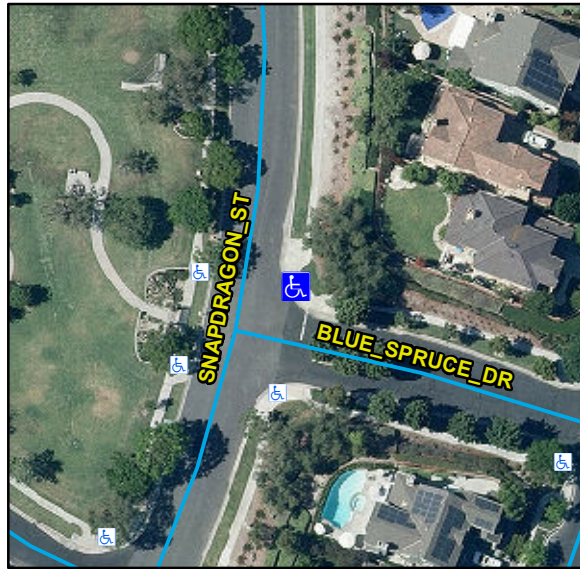
| Compliance | Description | Data | Compliance | Description | Data |
|---|---|---|---|---|---|
| No | Landing Width (in) | N/A | N/A | DWS Length (in) | N/A |
| No | Landing Run Slope (%) | N/A | N/A | DWS Full Width | N/A |
| No | Landing Cross Slope (%) | N/A | | DWS Offset Type | N/A |
| No | Gutter Run Slope (%) | 6.6 | | Road Cross Slope (%) | 1 |
| No | Gutter Cross Slope (%) | 2.5 | No | Perpendicular Joint Present | No |

Remove & Replace Curb Ramp With Two New Directional Ramps or Equivalent. Remove & Replace Gutter.
