# Access Compliance Report Public Rights-of-Way (Curb Ramps)

| Main Street: SIENNA_PKWY | | Cross Street: N_SELLAS_RD | | Location: | N |
| ADA ID: RPRK211109125446 | Ramp Type: Type 1 - Perpendicular | Initial Pass/Fail: Pass | Overall Compliance: No | Severity Score: | 15 |

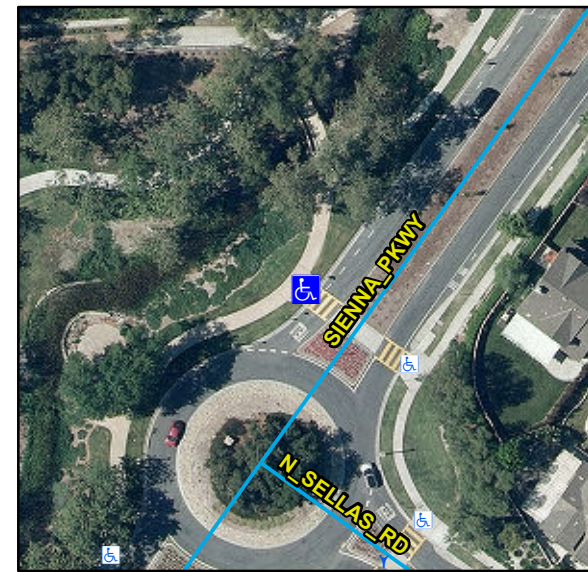
| Compliance | Description | Data | Compliance | Description | Data |
|---|---|---|---|---|---|
| No | Landing Run Slope (%) | 2.1 | N/A | Flare Traversable RT | No |
| Yes | Landing Cross Slope (%) | 0.7 | No | DWS Provided | No |
| No | Gutter Run Slope (%) | 10.1 | | Road Cross Slope (%) | N/A |
| No | Gutter Cross Slope (%) | 2.5 | | | |

**Remove & Replace Entire Ramp. Remove & Replace Gutter.**
