# Access Compliance Report Public Rights-of-Way (Curb Ramps)

| Main Street: SIENNA_PKWY | | Cross Street: N_SELLAS_RD | | Location: | W |
| ADA ID: RPRK211109125645 | Ramp Type: Type 1 - Perpendicular | Initial Pass/Fail: Fail | Overall Compliance: No | Severity Score: | 15 |

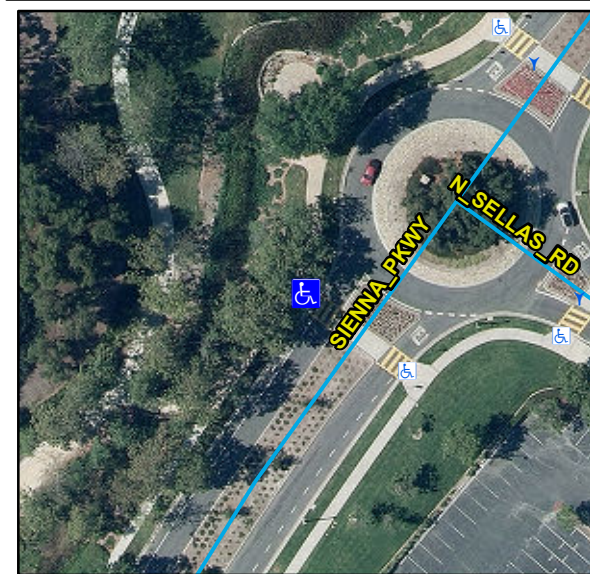
R304.2.2, R204.3, STD 1115

| Compliance | Description | Data | Compliance | Description | Data |
|---|---|---|---|---|---|
| No | Ramp Run Slope (%) | 9.2 | N/A | Flare Slope LT (%) | N/A |

Remove & Replace Entire Ramp.
