# Access Compliance Report Public Rights-of-Way (Curb Ramps)

Main Street: SIENNA\_PKWY Cross Street: N\_SELLAS\_RD Location: S

ADA ID: RPRK211109130053 Ramp Type: Type 1 - Perpendicular Initial Pass/Fail: Fail Overall Compliance: No Severity Score: 15

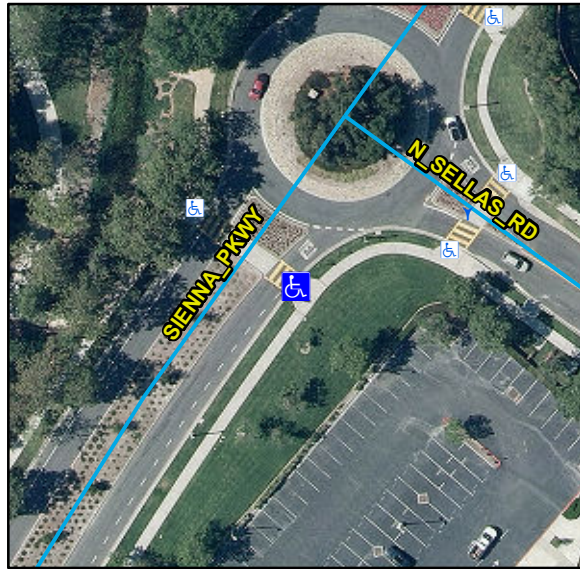
| Compliance | Description | Data | Compliance | Description | Data |
|---|---|---|---|---|---|
| No | Ramp Run Slope (%) | 9.1 | N/A | Flare Slope LT (%) | N/A |

Remove & Replace Entire Ramp.

R304.2.2, R204.3, STD 1115
