# Access Compliance Report Public Rights-of-Way (Curb Ramps)

Main Street: AVENDALE\_BLV D Cross Street: N\_SELLAS\_RD Location: NW

ADA ID: RPRK211109131121 Ramp Type: Type 4 - Parallel Initial Pass/Fail: Pass Overall Compliance: No Severity Score: 25

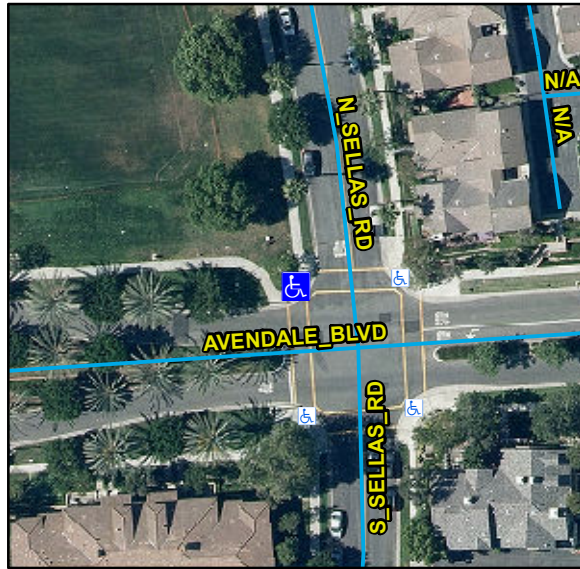
| Compliance | Description | Data | Compliance | Description | Data |
|---|---|---|---|---|---|
| N/A | Landing Present | No | No | DWS Provided | No |
| No | Landing Width (in) | N/A | N/A | DWS Length (in) | N/A |
| No | Landing Run Slope (%) | N/A | N/A | DWS Full Width | N/A |
| No | Landing Cross Slope (%) | N/A | | DWS Offset Type | N/A |
| Yes | Gutter Ponding | No | No | Curb Slope | 10.9 |
| No | Gutter Run Slope (%) | 9.4 | | Road Cross Slope (%) | 4.7 |
| No | Gutter Cross Slope (%) | 4.2 | No | Perpendicular Joint Present | No |

Remove & Replace Curb Ramp With Two New Directional Ramps or Equivalent. Remove & Replace Gutter.
