# Access Compliance Report Public Rights-of-Way (Curb Ramps)

| Main Street: N_SELLAS_RD | | Cross Street: AVENDALE_BLV | | Location: | NE |
| ADA ID: RPRK211109131505 | Ramp Type: Type 4 - Parallel | Initial Pass/Fail: Fail | Overall Compliance: No | Severity Score: | 16 |

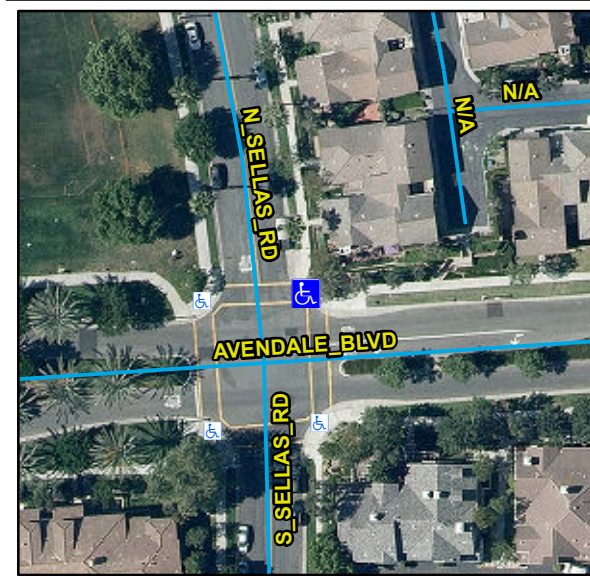
| Compliance | Description | Data | Compliance | Description | Data |
|---|---|---|---|---|---|
| Yes | Ramp Run Slope LT (%) | 3.1 | No | Ramp Run Slope RT (%) | 9 |
| No | Ramp Cross Slope LT (%) | 3 | No | Ramp Cross Slope RT (%) | 2.1 |

**Remove & Replace Curb Ramp With Two New Directional Ramps or Equivalent.**

**R204.3, R304.5.3, R304.3.2, STD 1115**

Total Cost: \$ 4000
