# Access Compliance Report Public Rights-of-Way (Curb Ramps)

| Main Street: AVENDALE_BLV | | Cross Street: S_SELLAS_RD | | Location: | S |
| ADA ID: RPRK211109131654 | Ramp Type: Type 4 - Parallel | Initial Pass/Fail: Fail | Overall Compliance: No | Severity Score: | 15 |

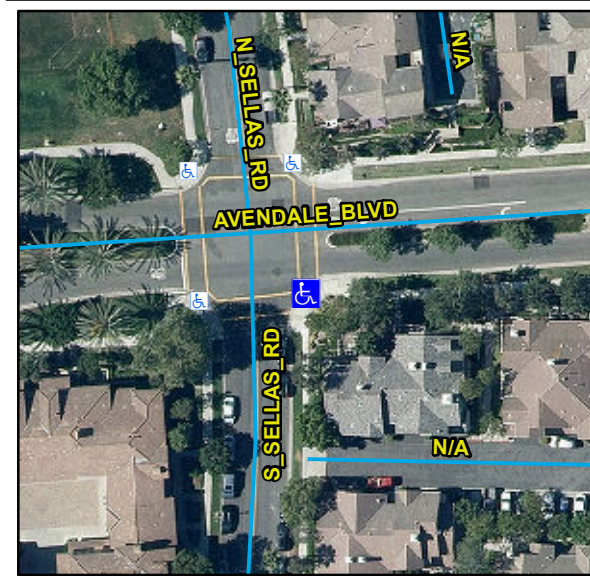
| Compliance | Description | Data | Compliance | Description | Data |
|---|---|---|---|---|---|
| No | Ramp Run Slope LT (%) | 9.6 | Yes | Ramp Run Slope RT (%) | 0.5 |

Possible Solutions:

**Remove & Replace Curb Ramp With Two New Directional Ramps or Equivalent.**

R304.3.2, STD 1115

Total Cost: \$ 4000

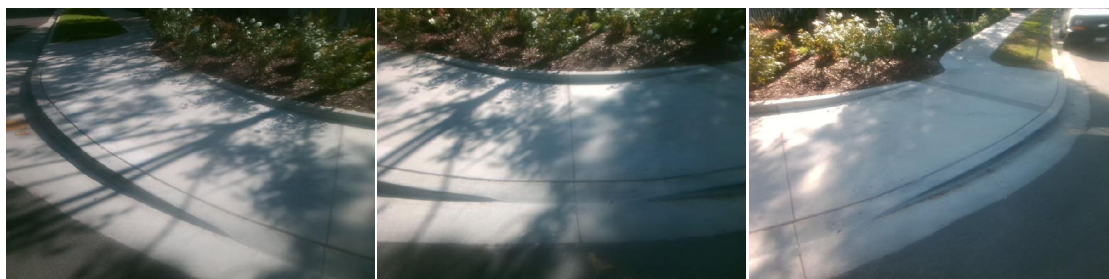
| Compliance | Description | Data | Compliance | Description | Data |
|---|---|---|---|---|---|
| N/A | Ramp Length LT (in) | 130 | N/A | Ramp Length RT (in) | 130 |
| Yes | Ramp Width LT (in) | 89 | Yes | Ramp Width RT (in) | 89 |
| Yes | Ramp Cross Slope LT (%) | 0.1 | Yes | Ramp Cross Slope RT (%) | 0.1 |
