# Access Compliance Report Public Rights-of-Way (Curb Ramps)

Main Street: S\_SELLAS\_RD Cross Street: AVENDALE\_BLVD Location: SW

ADA ID: RPRK211109131851 Ramp Type: Type 4 - Parallel Initial Pass/Fail: Fail Overall Compliance: No Severity Score: 2

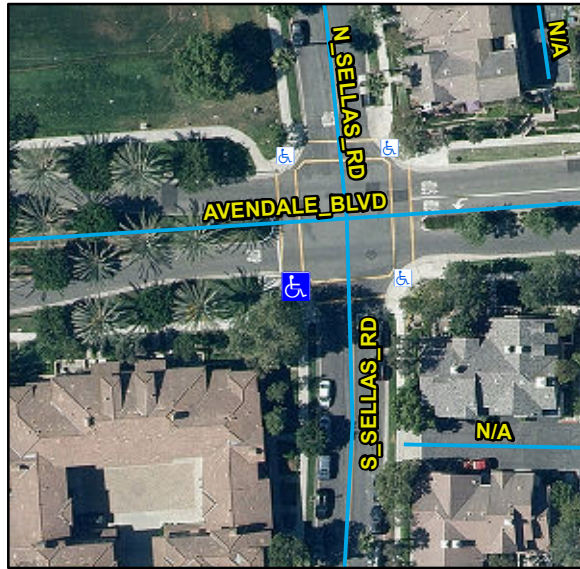
| Compliance | Description | Data | Compliance | Description | Data |
|---|---|---|---|---|---|
| Yes | Ramp Run Slope LT (%) | 2.3 | Yes | Ramp Run Slope RT (%) | 5.1 |
| No | Ramp Cross Slope LT (%) | 3.2 | No | Ramp Cross Slope RT (%) | 2.2 |

Remove & Replace Curb Ramp With Two New Directional Ramps or Equivalent.

R304.5.3, STD 1115

Total Cost: \$ 4000
