# Access Compliance Report Public Rights-of-Way (Curb Ramps)

Main Street: N/A Cross Street: TERRACE\_RD Location: E

ADA ID: RPRK211110113246 Ramp Type: Type 4 - Parallel Initial Pass/Fail: Fail Overall Compliance: No Severity Score: 2

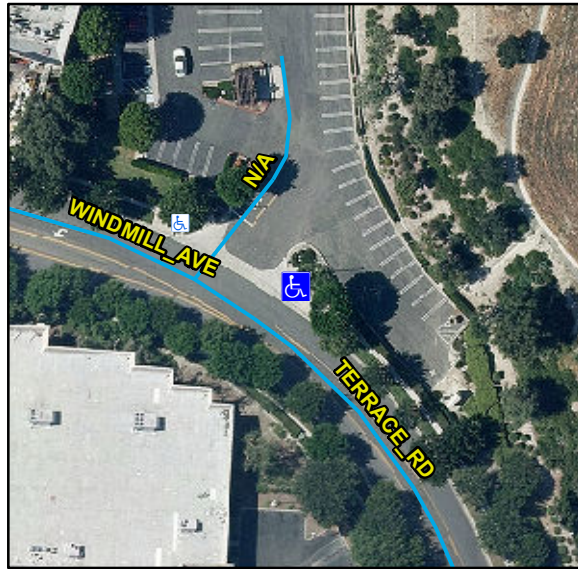
| Compliance | Description | Data | Compliance | Description | Data |
|---|---|---|---|---|---|
| No | Ramp Cross Slope LT (%) | 3 | No | Ramp Cross Slope RT (%) | 3.4 |

Remove & Replace Curb Ramp With Two New Directional Ramps or Equivalent.

R204.3, R304.5.3, STD 1115
