# Access Compliance Report Public Rights-of-Way (Curb Ramps)

| Main Street: WINDMILL_AVE | | Cross Street: N/A | | Location: | N |

| ADA ID: RPRK211110113451 | Ramp Type: Type 4 - Parallel | Initial Pass/Fail: Fail | Overall Compliance: No | Severity Score: | 15 |

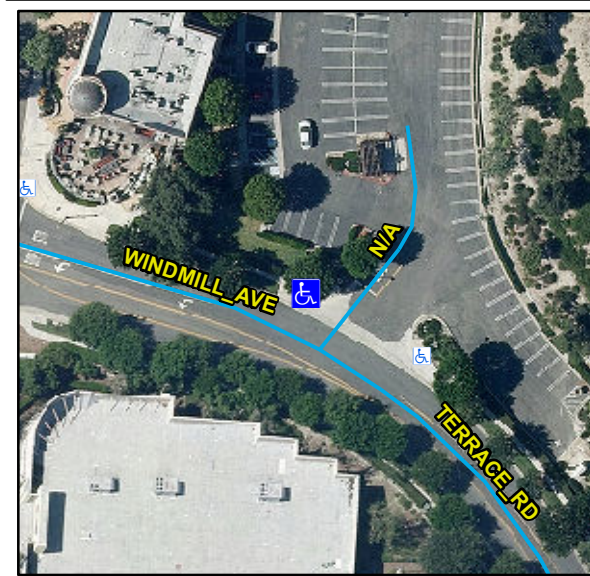
| Compliance | Description | Data | Compliance | Description | Data |
|---|---|---|---|---|---|
| No | Ramp Cross Slope LT (%) | 3 | No | Ramp Cross Slope RT (%) | 5.6 |

**Remove & Replace Curb Ramp With Two New Directional Ramps or Equivalent.**

**R204.3, R304.5.3, STD 1115**

Total Cost: \$ 4000

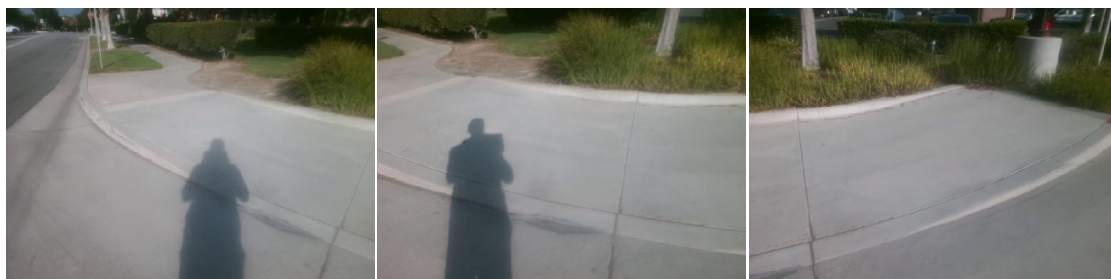
| Compliance | Description | Data | Compliance | Description | Data |
|---|---|---|---|---|---|
| N/A | Ramp Length LT (in) | 138 | N/A | Ramp Length RT (in) | 140 |
| Yes | Ramp Width LT (in) | 89 | Yes | Ramp Width RT (in) | 89 |
| Yes | Ramp Run Slope LT (%) | 2.4 | Yes | Ramp Run Slope RT (%) | 8.1 |
