# Access Compliance Report Public Rights-of-Way (Curb Ramps)

| Main Street: N/A | | Cross Street: WINDMILL_AVE | | Location: | E |
| ADA ID: RPRK211110113717 | Ramp Type: Type 4 - Parallel | Initial Pass/Fail: Fail | Overall Compliance: No | Severity Score: | 15 |

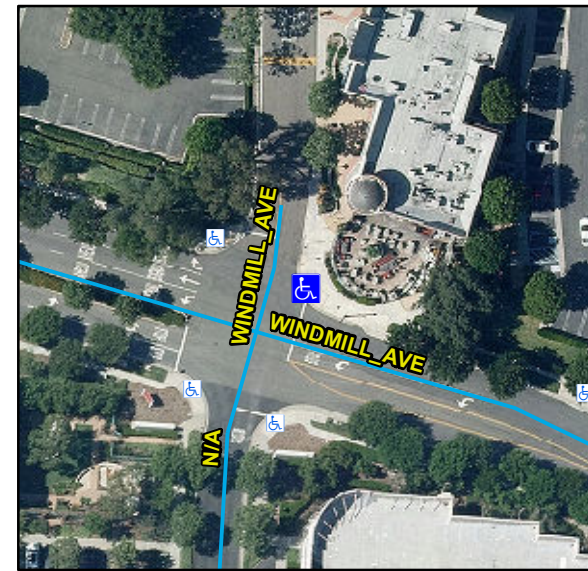
| Compliance | Description | Data | Compliance | Description | Data |
|---|---|---|---|---|---|
| Yes | Ramp Run Slope LT (%) | 2.4 | Yes | Ramp Run Slope RT (%) | 7.3 |
| No | Ramp Cross Slope LT (%) | 4.6 | No | Ramp Cross Slope RT (%) | 5.3 |

**Remove & Replace Curb Ramp With Two New Directional Ramps or Equivalent.**

**R304.5.3, STD 1115**

Total Cost: \$ 4000
