# Access Compliance Report Public Rights-of-Way (Curb Ramps)

Main Street: WINDMILL\_AVE Cross Street: N/A Location: N

ADA ID: RPRK211110114000 Ramp Type: Type 4 - Parallel Initial Pass/Fail: Fail Overall Compliance: No Severity Score: 2

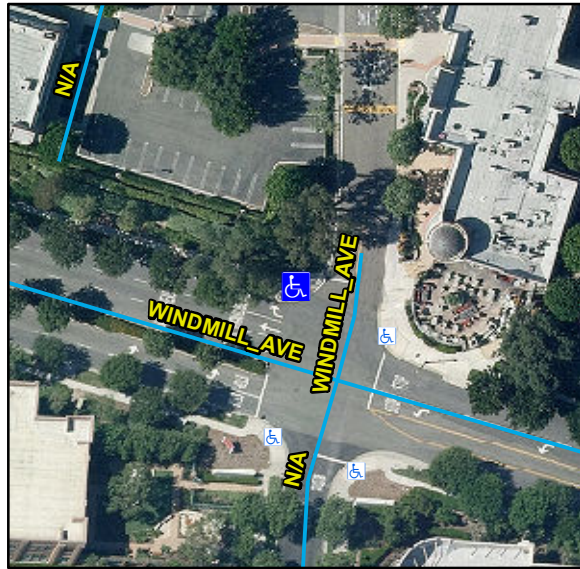
| Compliance | Description | Data | Compliance | Description | Data |
|---|---|---|---|---|---|
| Yes | Ramp Run Slope LT (%) | 2.6 | Yes | Ramp Run Slope RT (%) | 7.9 |
| No | Ramp Cross Slope LT (%) | 3.2 | Yes | Ramp Cross Slope RT (%) | 1.9 |
| N/A | Gutter Ponding | N/A | No | Curb Slope | 11.1 |
| N/A | Gutter Cross Slope (%) | N/A | No | Perpendicular Joint Present | No |

Remove & Replace Curb Ramp With Two New Directional Ramps or Equivalent.

R304.2.2, R204.3, R304.5.3, STD 1115

Total Cost: \$ 4000
