# Access Compliance Report Public Rights-of-Way (Curb Ramps)

Main Street: N/A Cross Street: WINDMILL\_AVE Location: SW

ADA ID: RPRK211110114210 Ramp Type: Type 4 - Parallel Initial Pass/Fail: Pass Overall Compliance: No Severity Score: 20

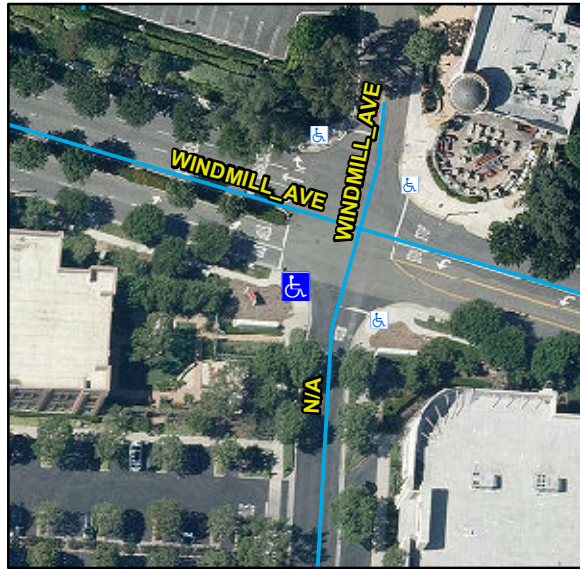
| Compliance | Description | Data | Compliance | Description | Data |
|---|---|---|---|---|---|
| N/A | Landing Present | No | No | DWS Provided | No |
| No | Landing Width (in) | N/A | N/A | DWS Length (in) | N/A |
| No | Landing Run Slope (%) | N/A | N/A | DWS Full Width | N/A |
| No | Landing Cross Slope (%) | N/A | | DWS Offset Type | N/A |
| Yes | Gutter Ponding | No | No | Curb Slope | 9.5 |
| Yes | Gutter Cross Slope (%) | 1.5 | No | Perpendicular Joint Present | No |

Remove & Replace Curb Ramp With Two New Directional Ramps or Equivalent.

R304.2.2, R204.3, R304.2.1, R304.2.2-Perp, R304.3.2-Para, R304.5.3, R305, STD 1115

Total Cost: \$ 4000
