# Access Compliance Report Public Rights-of-Way (Curb Ramps)

| Main Street: WINDMILL_AVE | | Cross Street: N/A | | Location: | S |
| ADA ID: RPRK211110114445 | Ramp Type: Type 4 - Parallel | Initial Pass/Fail: Fail | Overall Compliance: No | Severity Score: | 2 |

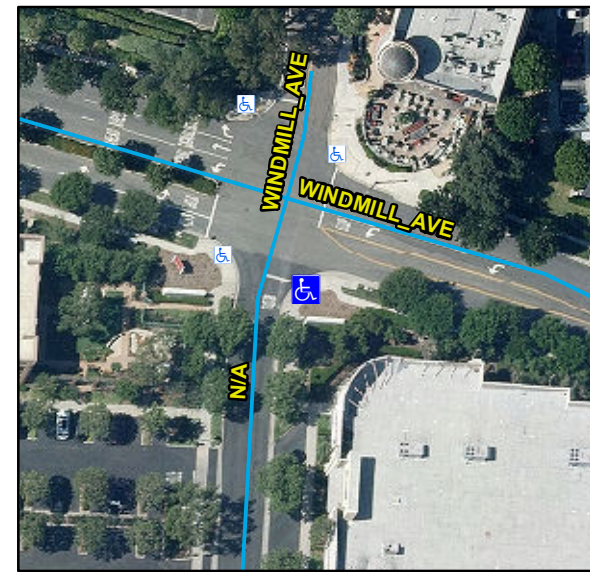
| Compliance | Description | Data | Compliance | Description | Data |
|---|---|---|---|---|---|
| No | Ramp Cross Slope LT (%) | 2.4 | No | Ramp Cross Slope RT (%) | 2.7 |

**Remove & Replace Curb Ramp With Two New Directional Ramps or Equivalent.**

**R204.3, R304.5.3, STD 1115**

Total Cost: \$ 4000
