# Access Compliance Report Public Rights-of-Way (Curb Ramps)

Main Street: DORRANCE\_DR Cross Street: SIENNA\_PKWY Location: W

ADA ID: RPRK211110124253 Ramp Type: Type 1 - Perpendicular Initial Pass/Fail: Fail Overall Compliance: No Severity Score: 2

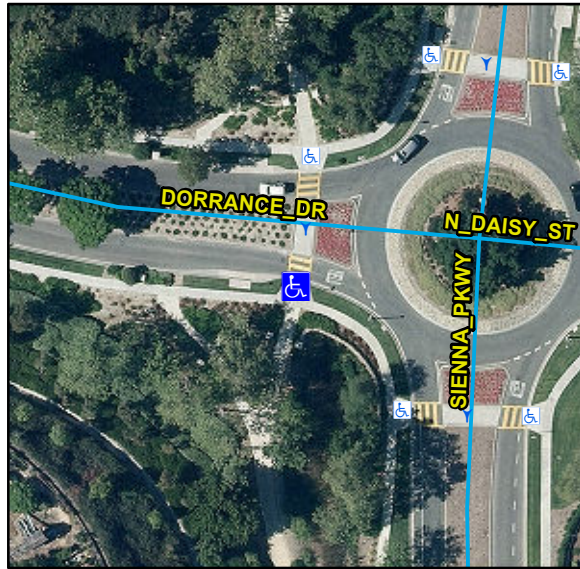
| Compliance | Description | Data | Compliance | Description | Data |
|---|---|---|---|---|---|
| No | Ramp Cross Slope (%) | 2.4 | N/A | Flare Traversable LT | N/A |

Remove & Replace Entire Ramp.
