# Access Compliance Report Public Rights-of-Way (Curb Ramps)

| Main Street: SIENNA_PKWY | | Cross Street: DORRANCE_DR | | Location: | S |
| ADA ID: RPRK211110124525 | Ramp Type: Type 1 - Perpendicular | Initial Pass/Fail: Fail | Overall Compliance: No | Severity Score: | 15 |

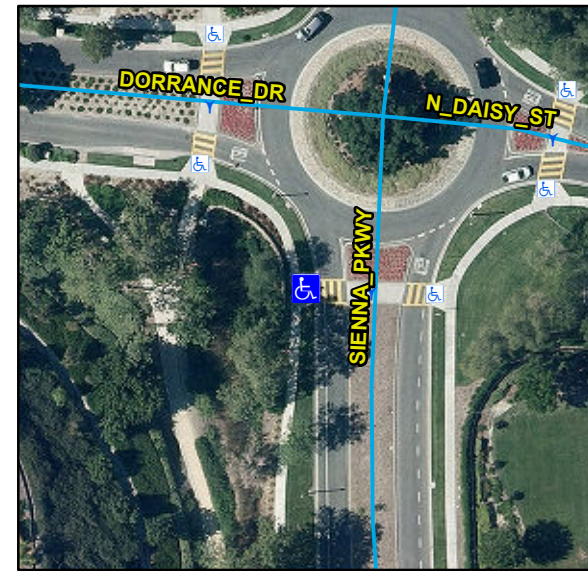
R304.2.2, STD 1115

| Compliance | Description | Data | Compliance | Description | Data |
|---|---|---|---|---|---|
| No | Ramp Run Slope (%) | 8.8 | N/A | Flare Slope LT (%) | N/A |

Remove & Replace Entire Ramp.

Total Cost: \$ 3080
