# Access Compliance Report Public Rights-of-Way (Curb Ramps)

Main Street: SIENNA\_PKWY Cross Street: N\_DAISSY\_ST Location: S

ADA ID: RPRK211110124843 Ramp Type: Type 1 - Perpendicular Initial Pass/Fail: Fail Overall Compliance: No Severity Score: 15

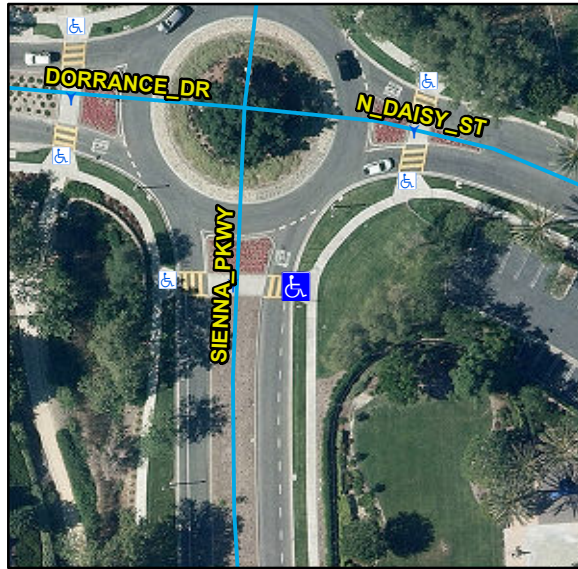
| Compliance | Description | Data | Compliance | Description | Data |
|---|---|---|---|---|---|
| No | Ramp Run Slope (%) | 10.8 | N/A | Flare Slope LT (%) | N/A |
| N/A | Gutter Ponding | N/A | No | Curb Slope | 9.3 |

Remove & Replace Entire Ramp.

R304.2.2, R204.3, STD 1115
