# Access Compliance Report Public Rights-of-Way (Curb Ramps)

| Main Street: N_DAISSY_ST | | Cross Street: SIENNA_PKWY | | Location: | E |
| ADA ID: RPRK211110125011 | Ramp Type:Type 1 - Perpendicular | Initial Pass/Fail: Pass | Overall Compliance: No | Severity Score: | 16 |

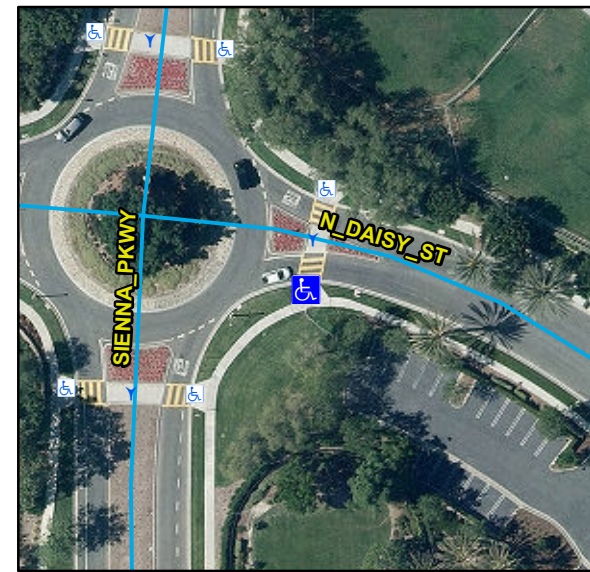
| Compliance | Description | Data | Compliance | Description | Data |
|---|---|---|---|---|---|
| No | Landing Run Slope (%) | 2.4 | N/A | Flare Traversable RT | No |
| Yes | Landing Cross Slope (%) | 0.6 | No | DWS Provided | No |
| Yes | Gutter Ponding | No | No | Curb Slope | 12 |
| No | Gutter Run Slope (%) | 9.1 | | Road Cross Slope (%) | N/A |

Possible Solutions:

**Remove & Replace Entire Ramp. Remove & Replace Gutter.**

**R304.2.2, R304.2.2-Perp, R304.3.2-Para, R305, R304.5.4, STD 1115**
