# Access Compliance Report Public Rights-of-Way (Curb Ramps)

| Main Street: N_Daisy_St | | Cross Street: SIENNA_Pkwy | | Location: | E |
| ADA ID: RPRK211110130005 | Ramp Type: Type 1 - Perpendicular | Initial Pass/Fail: Fail | Overall Compliance: No | Severity Score: | 16 |

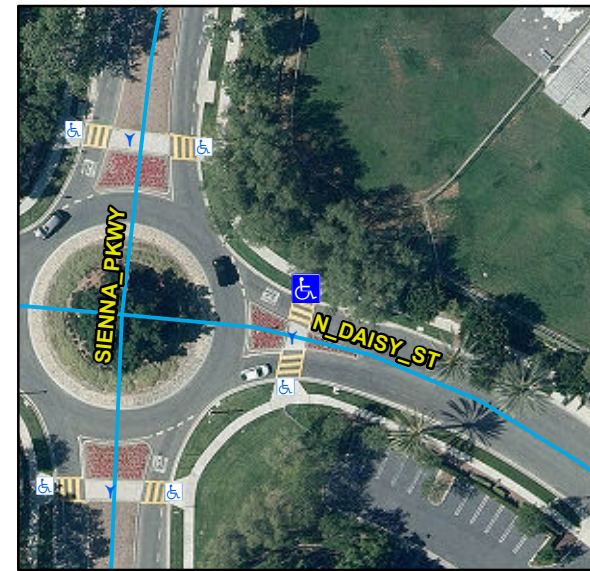
| Compliance | Description | Data | Compliance | Description | Data |
|---|---|---|---|---|---|
| No | Ramp Run Slope (%) | 11.2 | N/A | Flare Slope LT (%) | N/A |
| No | Ramp Cross Slope (%) | 3.1 | N/A | Flare Traversable LT | N/A |

Remove & Replace Entire Ramp.

R204.3, R304.2.2, R304.5.3, STD 1115
