# Access Compliance Report Public Rights-of-Way (Curb Ramps)

Main Street: SIENNA\_PKWY Cross Street: DORRANCE\_DR Location: N

ADA ID: RPRK211110130507 Ramp Type: Type 1 - Perpendicular Initial Pass/Fail: Pass Overall Compliance: No Severity Score: 16

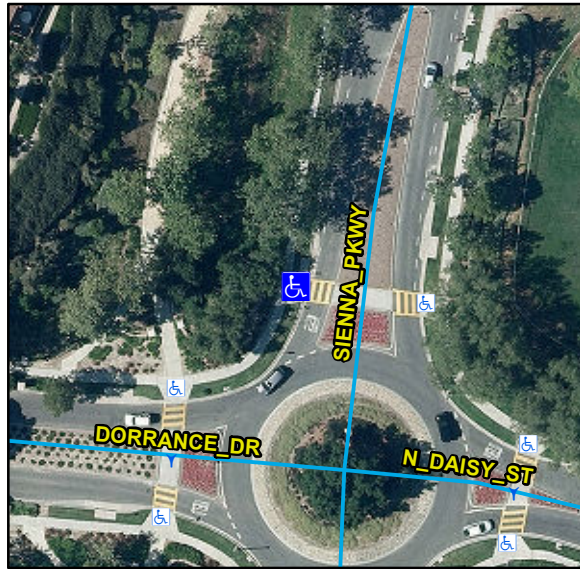
| Compliance | Description | Data | Compliance | Description | Data |
|---|---|---|---|---|---|
| No | Landing Run Slope (%) | 3.9 | N/A | Flare Traversable RT | No |
| Yes | Landing Cross Slope (%) | 0.1 | No | DWS Provided | No |
| Yes | Gutter Ponding | No | No | Curb Slope | 11.7 |
| No | Gutter Run Slope (%) | 7.6 | | Road Cross Slope (%) | N/A |
| No | Gutter Cross Slope (%) | 2.9 | | | |

Remove & Replace Entire Ramp. Remove & Replace Gutter.
