# Access Compliance Report Public Rights-of-Way (Curb Ramps)

| Main Street: DORRANCE_DR | | Cross Street: SIENNA_PKWY | | Location: | W |
| ADA ID: RPRK211110130705 | Ramp Type: Type 1 - Perpendicular | Initial Pass/Fail: Fail | Overall Compliance: No | Severity Score: | 15 |

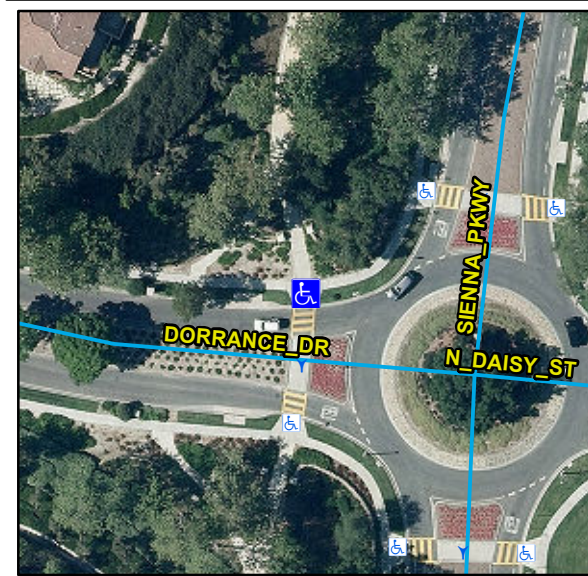
| Compliance | Description | Data | Compliance | Description | Data |
|---|---|---|---|---|---|
| No | Ramp Run Slope (%) | 9.2 | N/A | Flare Slope LT (%) | N/A |

Possible Solutions:

Remove & Replace Entire Ramp.
