# Access Compliance Report Public Rights-of-Way (Curb Ramps)

| Main Street: DORRANCE_DR | | Cross Street: DORRANCE_DR | | Location: | E |
| ADA ID: RPRK211110131153 | Ramp Type:Type 1 - Perpendicular | Initial Pass/Fail: Pass | Overall Compliance: No | Severity Score: | 35 |

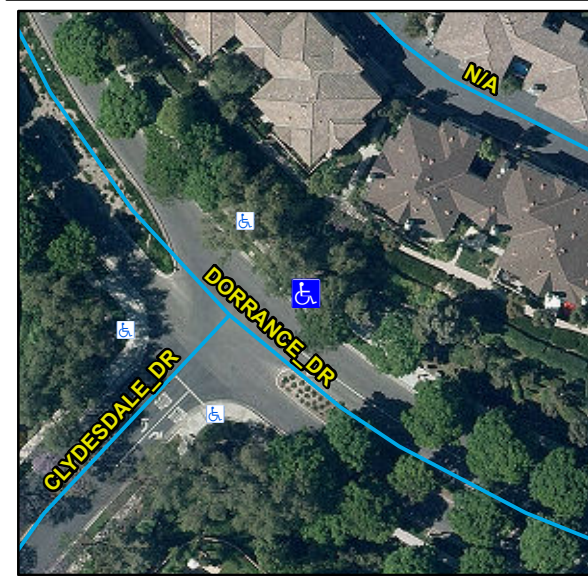
| Compliance | Description | Data | Compliance | Description | Data |
|---|---|---|---|---|---|
| No | Ramp Cross Slope (%) | 6 | N/A | Flare Traversable LT | No |
| No | Landing Cross Slope (%) | 9.7 | No | DWS Provided | No |
| Yes | Gutter Ponding | No | No | Curb Slope | 11.3 |
| No | Gutter Run Slope (%) | 7.1 | | Road Cross Slope (%) | N/A |
| No | Gutter Cross Slope (%) | 9 | | | |

**Remove & Replace Entire Ramp. Remove & Replace Gutter.**
