# Access Compliance Report Public Rights-of-Way (Curb Ramps)

| Main Street: CLYDESDALE_DR | | Cross Street: DORRANCE_DR | | Location: | W |
| ADA ID: RPRK211110131519 | Ramp Type: Type 4 - Parallel | Initial Pass/Fail: Fail | Overall Compliance: No | Severity Score: | 32 |

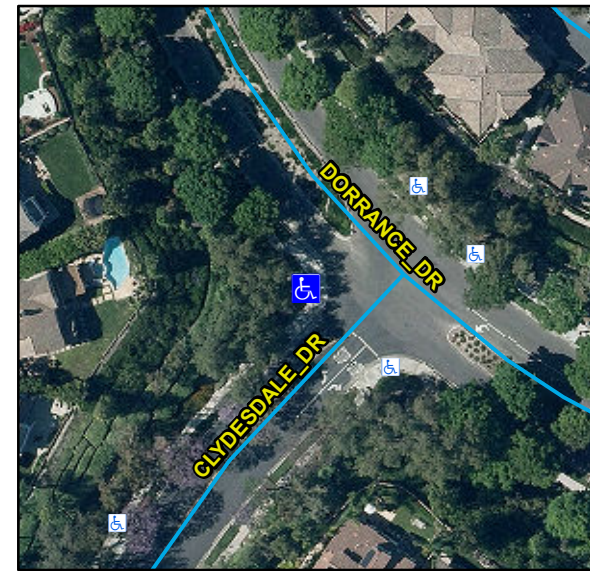
| Compliance | Description | Data | Compliance | Description | Data |
|---|---|---|---|---|---|
| Yes | Ramp Run Slope LT (%) | 1.6 | No | Ramp Run Slope RT (%) | 13.4 |
| No | Ramp Cross Slope LT (%) | 2.1 | No | Ramp Cross Slope RT (%) | 2.6 |

**Remove & Replace Curb Ramp With Two New Directional Ramps or Equivalent.**

**R204.3, R304.5.3, R304.3.2, STD 1115**

Total Cost: \$ 4000
