# Access Compliance Report Public Rights-of-Way (Curb Ramps)

| Main Street: DORRANCE_DR | | Cross Street: CLYDESDALE_DR | | Location: | S |
| ADA ID: RPRK211110131711 | Ramp Type: Type 4 - Parallel | Initial Pass/Fail: Fail | Overall Compliance: No | Severity Score: | 32 |

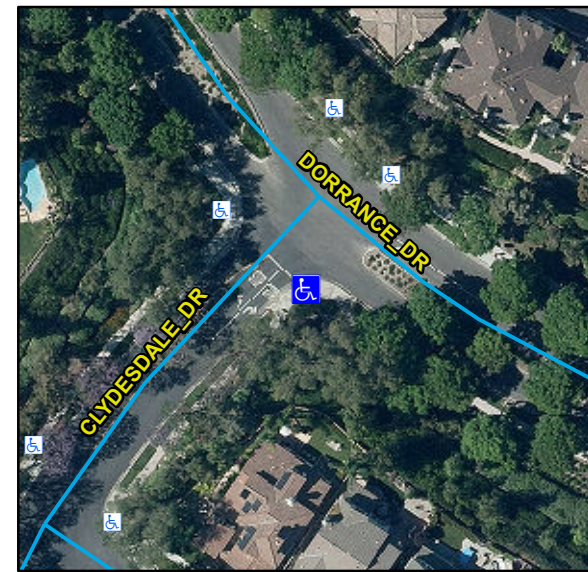
| Compliance | Description | Data | Compliance | Description | Data |
|---|---|---|---|---|---|
| Yes | Ramp Run Slope LT (%) | 4.1 | No | Ramp Run Slope RT (%) | 19.5 |
| No | Ramp Cross Slope LT (%) | 3.7 | Yes | Ramp Cross Slope RT (%) | 1.9 |

**Remove & Replace Curb Ramp With Two New Directional Ramps or Equivalent. Restripe Crosswalk.**

**R204.3, R304.5.3, R304.3.2, STD 1115**

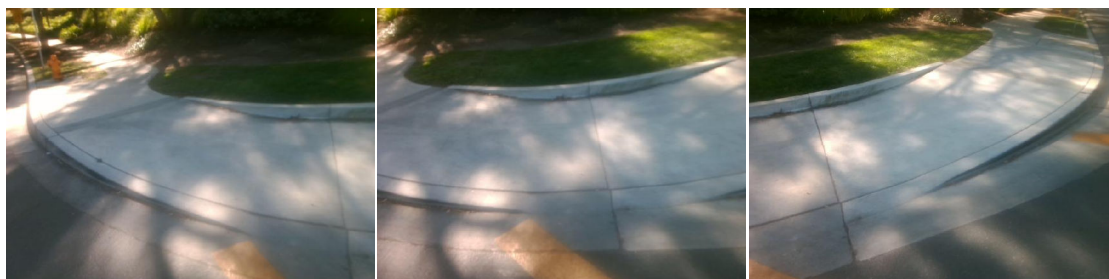
| Compliance | Description | Data | Compliance | Description | Data |
|---|---|---|---|---|---|
| Yes | Obstructions Present? | No | N/A | Utilities Present? | No |
