# Access Compliance Report Public Rights-of-Way (Curb Ramps)

Main Street: CLYDESDALE\_DR Cross Street: ABYSSINIAN\_WAY Location: E

ADA ID: RPRK211110132006 Ramp Type: Type 4 - Parallel Initial Pass/Fail: Fail Overall Compliance: No Severity Score: 32

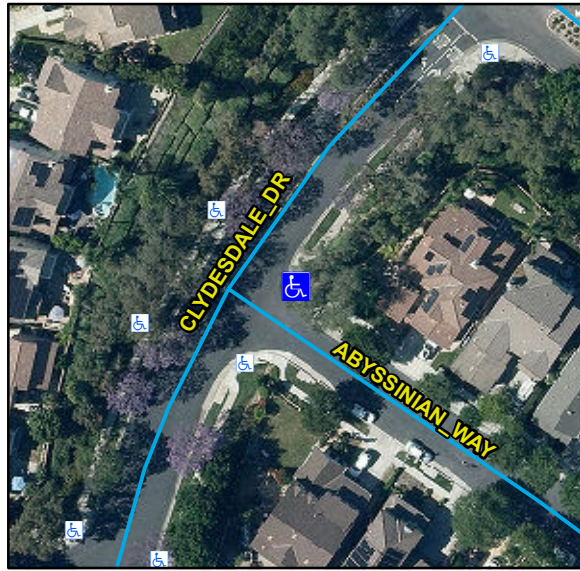
| Compliance | Description | Data | Compliance | Description | Data |
|---|---|---|---|---|---|
| Yes | Ramp Run Slope LT (%) | 7.8 | No | Ramp Run Slope RT (%) | 19.1 |
| No | Ramp Cross Slope LT (%) | 3.3 | Yes | Ramp Cross Slope RT (%) | 0.7 |

**Remove & Replace Curb Ramp With Two New Directional Ramps or Equivalent.**

**R204.3, R304.5.3, R304.3.2, STD 1115**
