# Access Compliance Report Public Rights-of-Way (Curb Ramps)

Main Street: CLYDESDALE\_DR Cross Street: CLYDESDALE\_DR Location: N

ADA ID: RPRK211110132206 Ramp Type: Type 1 - Perpendicular Initial Pass/Fail: Fail Overall Compliance: No Severity Score: 30

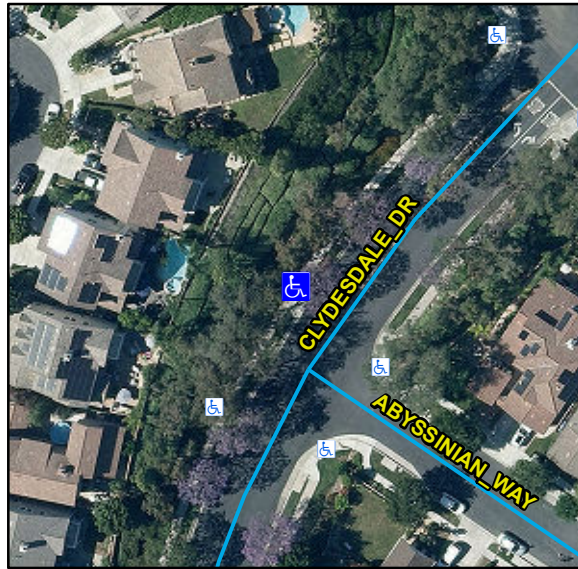
| Compliance | Description | Data | Compliance | Description | Data |
|---|---|---|---|---|---|
| No | Ramp Cross Slope (%) | 7.5 | N/A | Flare Traversable LT | N/A |
| N/A | Gutter Ponding | N/A | No | Curb Slope | 13 |

**Remove & Replace Entire Ramp.**

**R304.2.2, R204.3, R304.5.3, STD 1115**
