# Access Compliance Report Public Rights-of-Way (Curb Ramps)

| Main Street: ABYSSINIAN_WAY | | Cross Street: CLYDESDALE_DR | | Location: | S |
| ADA ID: RPRK211110132335 | Ramp Type: Type 4 - Parallel | Initial Pass/Fail: Fail | Overall Compliance: No | Severity Score: | 30 |

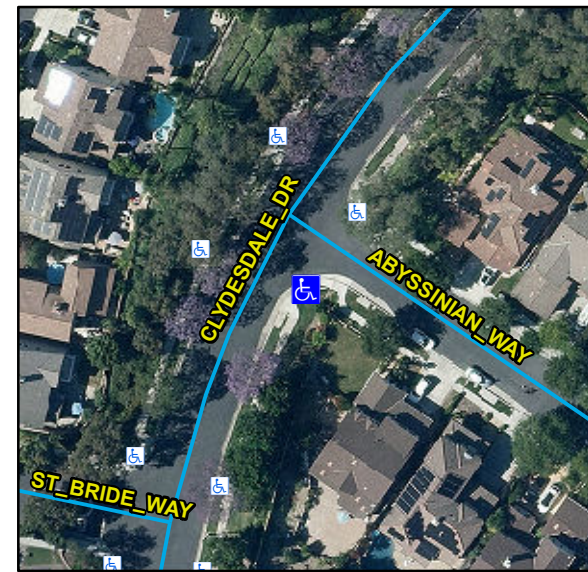
| Compliance | Description | Data | Compliance | Description | Data |
|---|---|---|---|---|---|
| Yes | Ramp Run Slope LT (%) | 2.8 | No | Ramp Run Slope RT (%) | 12.7 |

Possible Solutions:

**Remove & Replace Curb Ramp With Two New Directional Ramps or Equivalent.**

**R204.3, R304.3.2, STD 1115**
