# Access Compliance Report Public Rights-of-Way (Curb Ramps)

| Main Street: CLYDESDALE_DR | | Cross Street: CLYDESDALE_DR | | Location: | S |
| ADA ID: RPRK211110132627 | Ramp Type:Type 1 - Perpendicular | Initial Pass/Fail: Fail | Overall Compliance: No | Severity Score: | 30 |

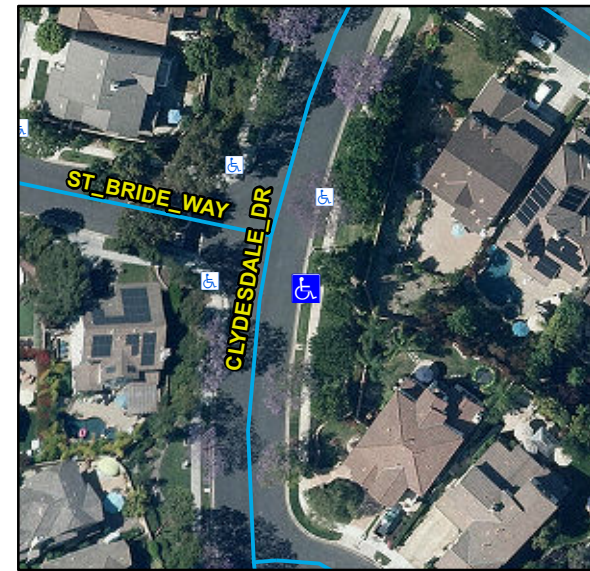
| Compliance | Description | Data | Compliance | Description | Data |
|---|---|---|---|---|---|
| No | Ramp Run Slope (%) | 9.9 | N/A | Flare Slope LT (%) | N/A |
| No | Ramp Cross Slope (%) | 5.4 | N/A | Flare Traversable LT | N/A |

**Remove & Replace Entire Ramp.**

**R304.2.2, R204.3, R304.5.3, STD 1115**

Total Cost: \$ 3080
