# Access Compliance Report Public Rights-of-Way (Curb Ramps)

Main Street: CLYDESDALE\_DR Cross Street: ST\_BRIDE\_WAY Location: W

ADA ID: RPRK211110132723 Ramp Type: Type 4 - Parallel Initial Pass/Fail: Fail Overall Compliance: No Severity Score: 16

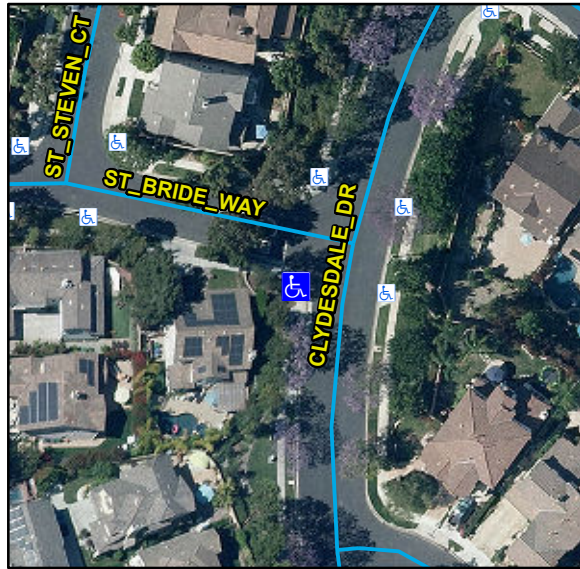
| Compliance | Description | Data | Compliance | Description | Data |
|---|---|---|---|---|---|
| No | Ramp Run Slope LT (%) | 8.8 | Yes | Ramp Run Slope RT (%) | 3.6 |
| Yes | Ramp Cross Slope LT (%) | 1.3 | No | Ramp Cross Slope RT (%) | 2.6 |

**Remove & Replace Curb Ramp With Two New Directional Ramps or Equivalent.**

**R204.3, R304.3.2, R304.5.3, STD 1115**
