# Access Compliance Report Public Rights-of-Way (Curb Ramps)

Main Street: ST\_BRIDE\_WAY Cross Street: CLYDESDALE\_DR Location: N

ADA ID: RPRK211110132933 Ramp Type: Type 4 - Parallel Initial Pass/Fail: Fail Overall Compliance: No Severity Score: 32

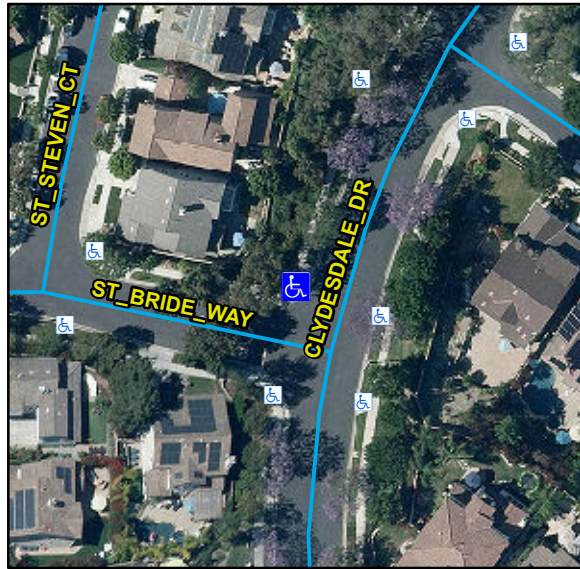
| Compliance | Description | Data | Compliance | Description | Data |
|---|---|---|---|---|---|
| No | Ramp Run Slope LT (%) | 14.2 | Yes | Ramp Run Slope RT (%) | 2.4 |
| No | Ramp Cross Slope LT (%) | 2.8 | No | Ramp Cross Slope RT (%) | 3.6 |

**Remove & Replace Curb Ramp With Two New Directional Ramps or Equivalent.**

**R204.3, R304.3.2, R304.5.3, STD 1115**
