# Access Compliance Report Public Rights-of-Way (Curb Ramps)

Main Street: ST\_STEVEN\_CT Cross Street: ST\_BRIDE\_WAY Location: E

ADA ID: RPRK211110133147 Ramp Type: Type 4 - Parallel Initial Pass/Fail: Pass Overall Compliance: No Severity Score: 22

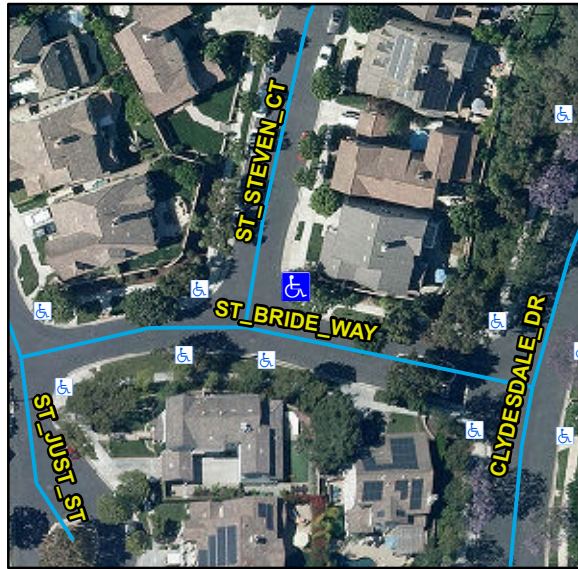
| Compliance | Description | Data | Compliance | Description | Data |
|---|---|---|---|---|---|
| No | Ramp Cross Slope LT (%) | 2.1 | Yes | Ramp Cross Slope RT (%) | 1 |
| No | Landing Width (in) | N/A | N/A | DWS Length (in) | N/A |
| No | Landing Run Slope (%) | N/A | N/A | DWS Full Width | N/A |
| No | Landing Cross Slope (%) | N/A | | DWS Offset Type | N/A |
| No | Gutter Cross Slope (%) | 3.2 | No | Perpendicular Joint Present | No |

Remove & Replace Curb Ramp With Two New Directional Ramps or Equivalent. Remove & Replace Gutter.
