# Access Compliance Report Public Rights-of-Way (Curb Ramps)

Main Street: ST\_JUST\_ST Cross Street: ST\_BRIDE\_WAY Location: NE

ADA ID: RPRK211110133619 Ramp Type: Type 4 - Parallel Initial Pass/Fail: Pass Overall Compliance: No Severity Score: 25

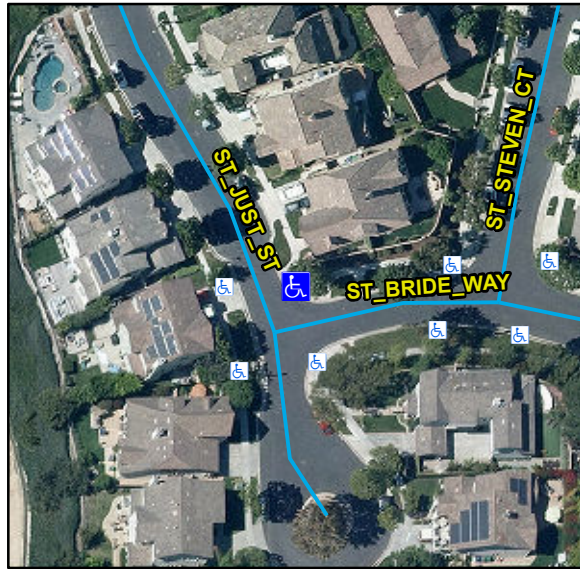
| Compliance | Description | Data | Compliance | Description | Data |
|---|---|---|---|---|---|
| N/A | Landing Present | No | No | DWS Provided | No |
| No | Landing Width (in) | N/A | N/A | DWS Length (in) | N/A |
| No | Landing Run Slope (%) | N/A | N/A | DWS Full Width | N/A |
| No | Landing Cross Slope (%) | N/A | | DWS Offset Type | N/A |
| No | Gutter Run Slope (%) | 8.7 | | Road Cross Slope (%) | 5.5 |

Remove & Replace Curb Ramp With Two New Directional Ramps or Equivalent. Remove & Replace Gutter.

R204.3, R304.2.1, R304.2.2-Perp, R304.3.2-Para, R304.5.3, R305, R304.5.4, STD 1115
