# Access Compliance Report Public Rights-of-Way (Curb Ramps)

Main Street: ST\_BRIDE\_WAY Cross Street: ST\_JUST\_ST Location: SE

ADA ID: RPRK211110133925 Ramp Type: Type 4 - Parallel Initial Pass/Fail: Fail Overall Compliance: No Severity Score: 2

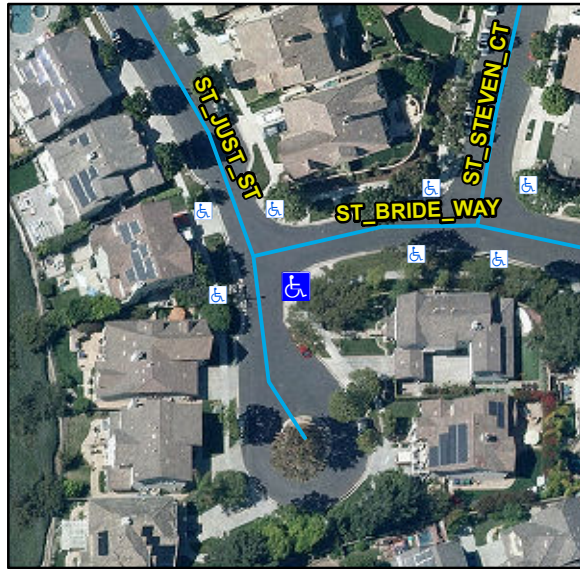
| Compliance | Description | Data | Compliance | Description | Data |
|---|---|---|---|---|---|
| No | Ramp Cross Slope LT (%) | 2.8 | Yes | Ramp Cross Slope RT (%) | 0.5 |

Remove & Replace Curb Ramp With Two New Directional Ramps or Equivalent.

R204.3, R304.5.3, STD 1115
