# Access Compliance Report Public Rights-of-Way (Curb Ramps)

| Main Street: ABYSSINIAN_WAY | | Cross Street: CLYDESDALE_DR | | Location: | SE |
| ADA ID: RPRK211110134639 | Ramp Type: Type 4 - Parallel | Initial Pass/Fail: Fail | Overall Compliance: No | Severity Score: | 2 |

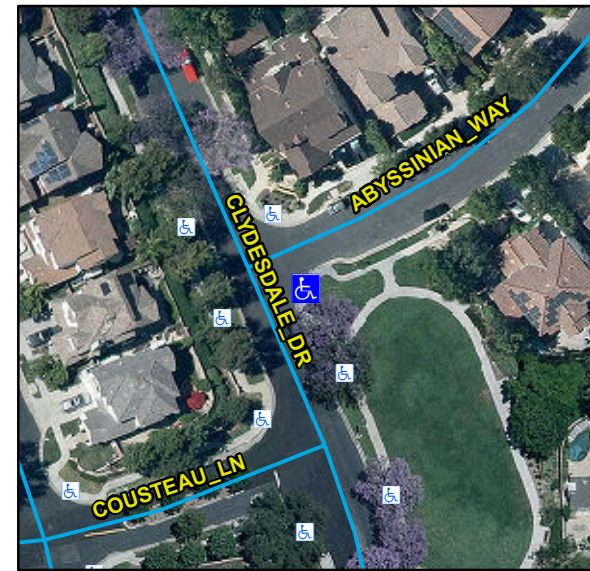
| Compliance | Description | Data | Compliance | Description | Data |
|---|---|---|---|---|---|
| Yes | Ramp Cross Slope LT (%) | 0.8 | No | Ramp Cross Slope RT (%) | 2.8 |
| N/A | Gutter Ponding | N/A | No | Curb Slope | 9.7 |

**Remove & Replace Curb Ramp With Two New Directional Ramps or Equivalent.**

**R304.2.2, R304.5.3, STD 1115**

Total Cost: \$ 4000
