# Access Compliance Report Public Rights-of-Way (Curb Ramps)

Main Street: CLYDESDALE\_DR Cross Street: COUSTEAU\_LN Location: SW

ADA ID: RPRK211110135059 Ramp Type: Type 4 - Parallel Initial Pass/Fail: Fail Overall Compliance: No Severity Score: 16

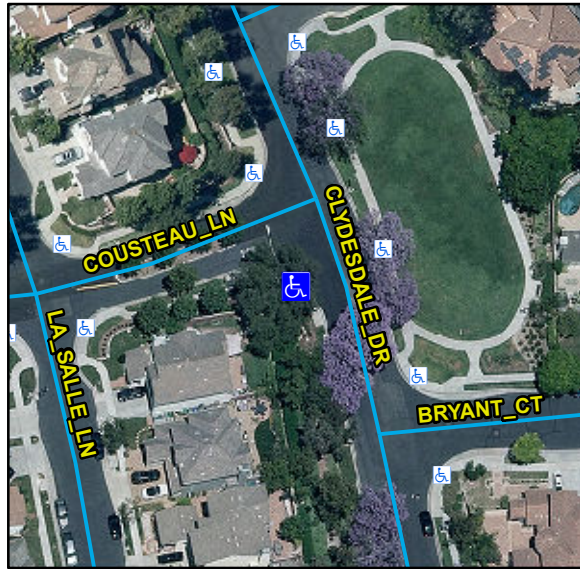
| Compliance | Description | Data | Compliance | Description | Data |
|---|---|---|---|---|---|
| Yes | Ramp Run Slope LT (%) | 1.6 | No | Ramp Run Slope RT (%) | 10.2 |
| No | Ramp Cross Slope LT (%) | 3.2 | Yes | Ramp Cross Slope RT (%) | 1.9 |

Remove & Replace Curb Ramp With Two New Directional Ramps or Equivalent.

R204.3, R304.5.3, R304.3.2, STD 1115
