# Access Compliance Report Public Rights-of-Way (Curb Ramps)

Main Street: COUSTEAU\_LN Cross Street: CLYDESDALE\_DR Location: NW

ADA ID: RPRK211110135308 Ramp Type: Type 4 - Parallel Initial Pass/Fail: Fail Overall Compliance: No Severity Score: 16

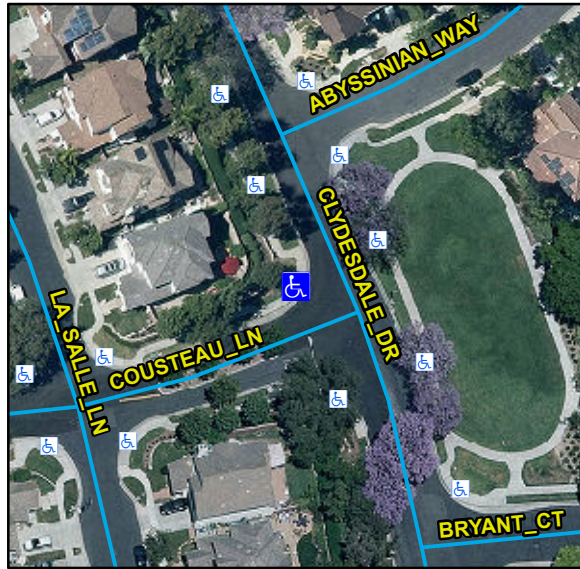
| Compliance | Description | Data | Compliance | Description | Data |
|---|---|---|---|---|---|
| Yes | Ramp Run Slope LT (%) | 0.6 | No | Ramp Run Slope RT (%) | 10.7 |
| No | Ramp Cross Slope LT (%) | 2.8 | Yes | Ramp Cross Slope RT (%) | 1.1 |

Remove & Replace Curb Ramp With Two New Directional Ramps or Equivalent.
