# Access Compliance Report Public Rights-of-Way (Curb Ramps)

| Main Street: LA_SALLE_LN | | Cross Street: COUSTEAU_LN | | Location: | NE |
| ADA ID: RPRK211110135517 | Ramp Type: Type 4 - Parallel | Initial Pass/Fail: Fail | Overall Compliance: No | Severity Score: | 15 |

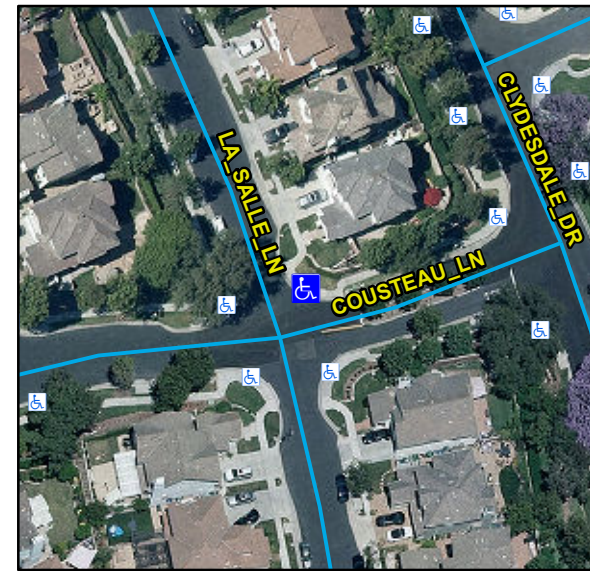
| Compliance | Description | Data | Compliance | Description | Data |
|---|---|---|---|---|---|
| No | Ramp Run Slope LT (%) | 10.4 | Yes | Ramp Run Slope RT (%) | 3 |

**Remove & Replace Curb Ramp With Two New Directional Ramps or Equivalent.**

**R204.3, R304.3.2, STD 1115**

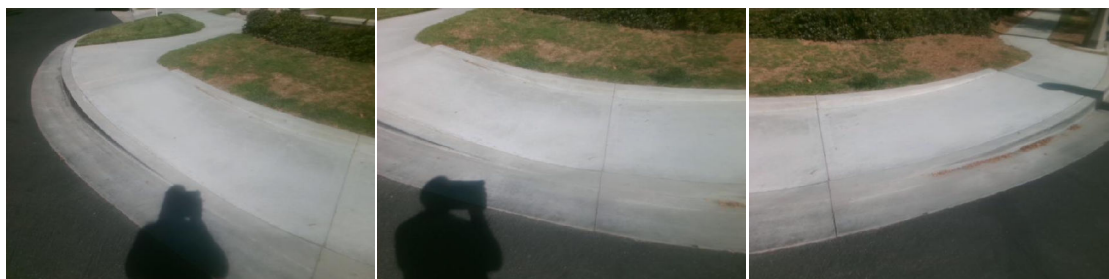
| Compliance | Description | Data | Compliance | Description | Data |
|---|---|---|---|---|---|
| N/A | Ramp Length LT (in) | 129 | N/A | Ramp Length RT (in) | 136 |
| Yes | Ramp Width LT (in) | 52 | Yes | Ramp Width RT (in) | 52 |
| Yes | Ramp Cross Slope LT (%) | 0 | Yes | Ramp Cross Slope RT (%) | 0.9 |
