# Access Compliance Report Public Rights-of-Way (Curb Ramps)

| Main Street: PAPETTE_CIR | | Cross Street: COUSTEAU_LN | | Location: | NE |

| ADA ID: RPRK211110135933 | Ramp Type: Type 4 - Parallel | Initial Pass/Fail: Fail | Overall Compliance: No | Severity Score: | 2 |

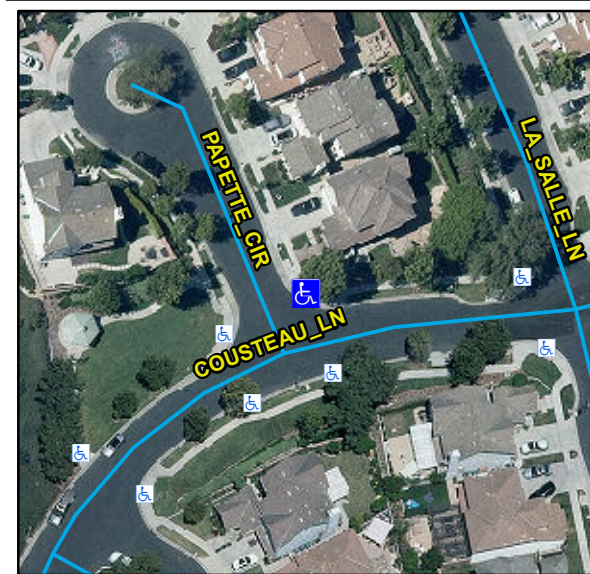
| Compliance | Description | Data | Compliance | Description | Data |
|---|---|---|---|---|---|
| Yes | Ramp Cross Slope LT (%) | 0.5 | No | Ramp Cross Slope RT (%) | 3.9 |

**Remove & Replace Curb Ramp With Two New Directional Ramps or Equivalent.**

**R204.3, R304.5.3, STD 1115**

Total Cost: \$ 4000
