# Access Compliance Report Public Rights-of-Way (Curb Ramps)

Main Street: COUSTEAU\_LN Cross Street: PAPETTE\_CIR Location: NW

ADA ID: RPRK211110140144 Ramp Type: Type 4 - Parallel Initial Pass/Fail: Pass Overall Compliance: No Severity Score: 25

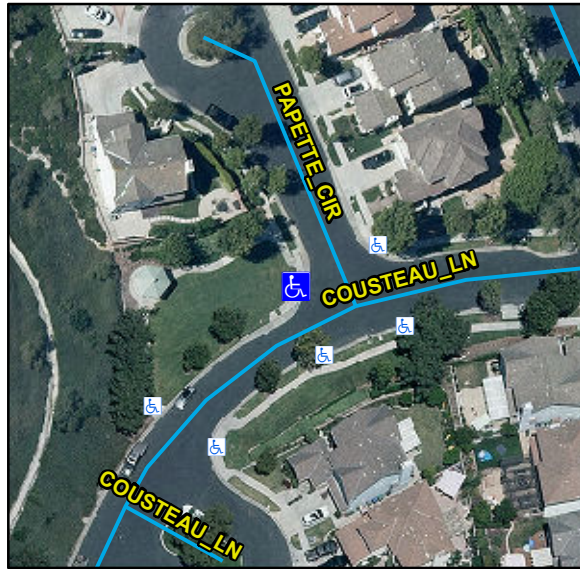
| Compliance | Description | Data | Compliance | Description | Data |
|---|---|---|---|---|---|
| N/A | Landing Present | No | No | DWS Provided | No |
| No | Landing Width (in) | N/A | N/A | DWS Length (in) | N/A |
| No | Landing Run Slope (%) | N/A | N/A | DWS Full Width | N/A |
| No | Landing Cross Slope (%) | N/A | | DWS Offset Type | N/A |
| No | Gutter Run Slope (%) | 8.4 | | Road Cross Slope (%) | 0.5 |
| No | Gutter Cross Slope (%) | 5.7 | No | Perpendicular Joint Present | No |

Remove & Replace Curb Ramp With Two New Directional Ramps or Equivalent. Remove & Replace Gutter.

R204.3, R304.2.1, R304.2.2-Perp, R304.3.2-Para, R304.5.3, R305, R304.5.4, STD 1115
